**Electron Dam
Rock Dam Structure Status Report and Listed Species Take
5/17/2022**

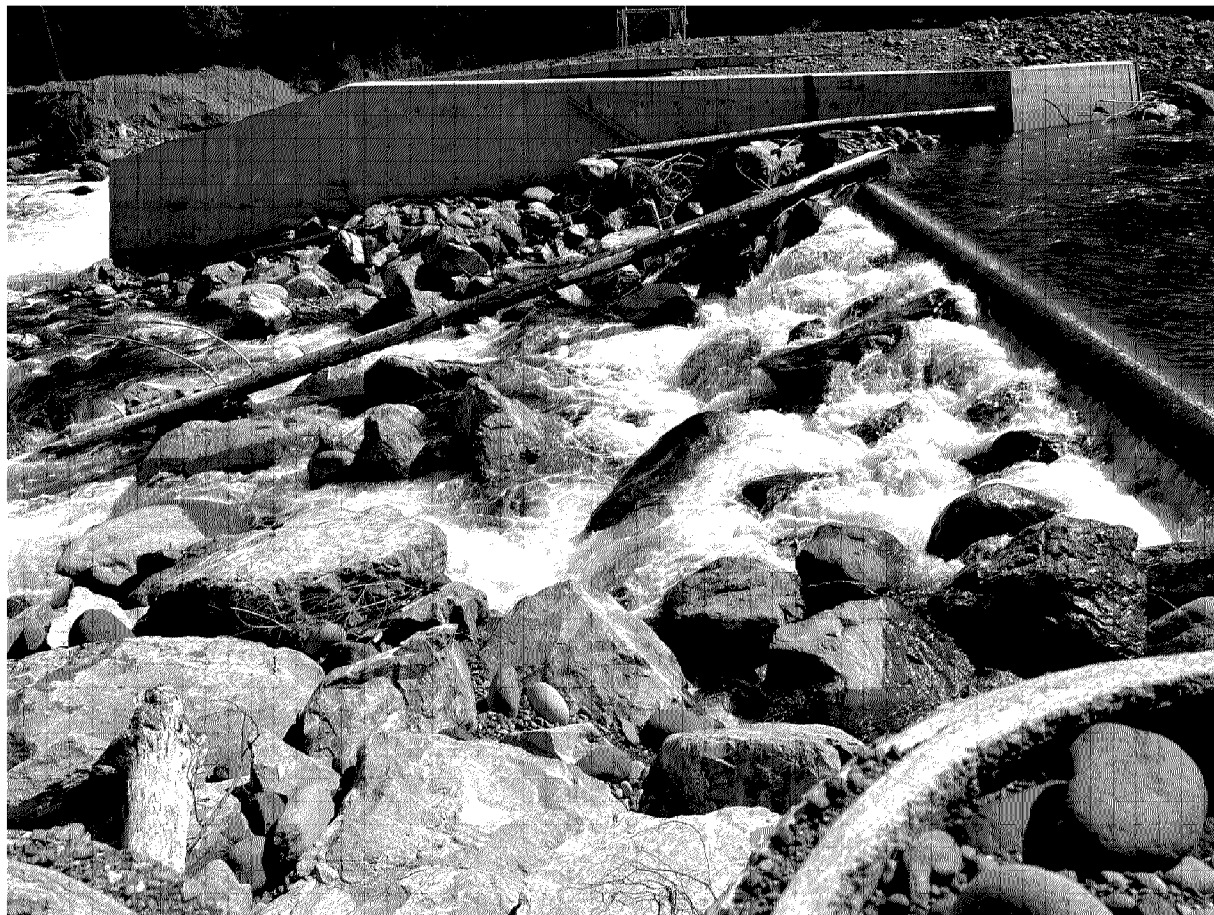
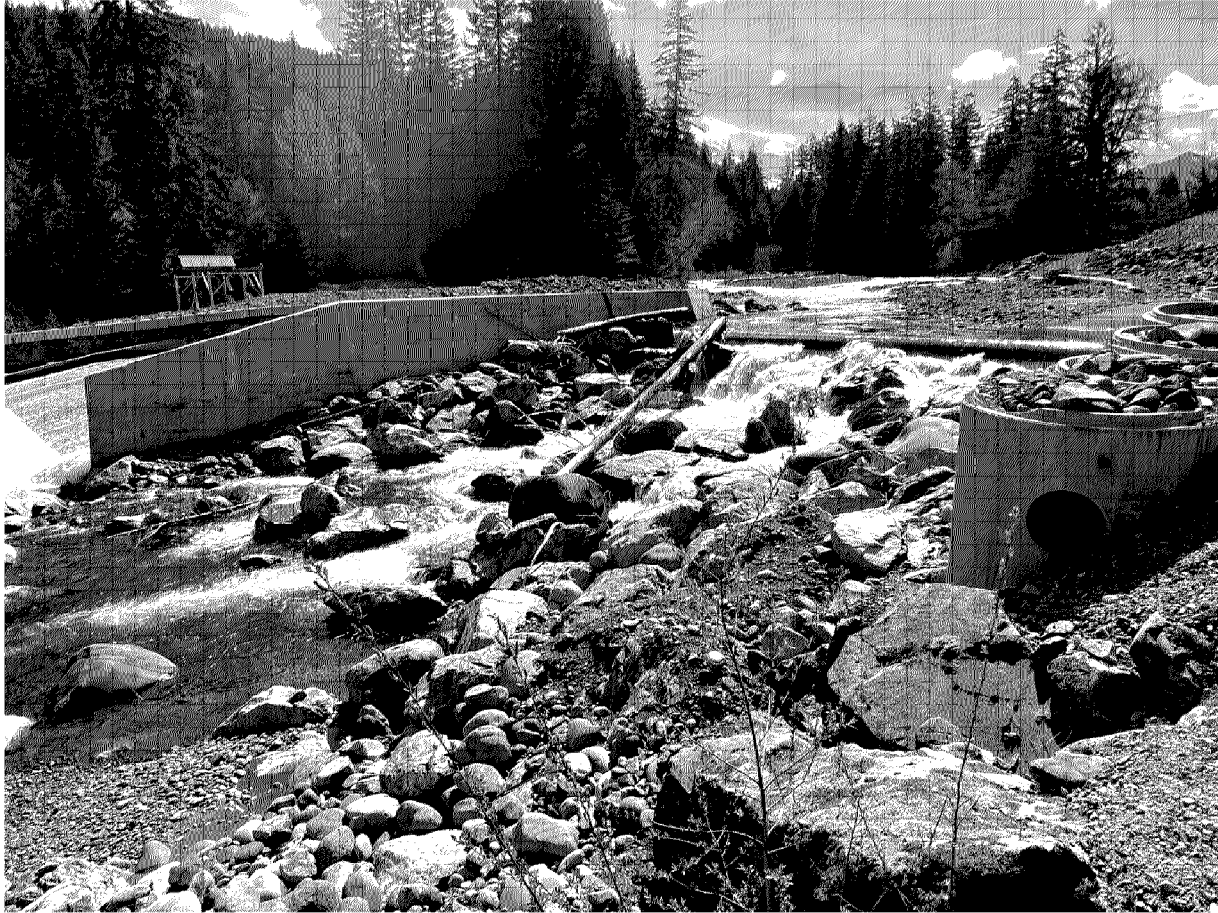
The area of large rock that was added downstream of the sheet pile dam has been stripped of all fine gravel, cobble and small rubble as predicted. What remains is highly angular boulders, with large voids that create an abrupt obstruction and provide little or no pool features that would allow for fish to stage a jump or to otherwise make successful passage upstream. While staging for successful passage is likely unavailable under current structure conditions, the flow over the rock dam continues to draw fish up into the structure to the point of the sheet pile, and they remain there prohibited from entering the fish ladder but also likely restricted from moving upstream. Once they are exhausted enough to potentially fall back, it is highly unlikely they will move laterally successfully to the fish ladder given the conditions downstream of the rock dam and turbulent conditions below the wood apron. Even if a fish could clear the required 6' vertical clearance at the steel sheet pile of the rock dam, while not impossible, is far from ideal much less desirable for a facility whose fish passage systems have been repeatedly called into question.

The rock dam feature now works in concert with the sheet pile flow over the wooden dam apron. This collective stream of water will act to confuse, disorient and exhaust all species in their quest to fish upstream passage.

The fact that so much flow goes over the sheetpile dam contributes to the attraction of upstream migrating fish. This very effectively leads to their exhaustion, injury and in all likelihood reduces their chances at reproducing successfully.

The rock dam itself is a barrier to fish passage, the increased height of the steel structure, which was not installed as permitted to begin with, now completely blocks fish passage, but the rock itself has once again moved during winter flows. So, once again, fish are drawn up river left with nowhere to go and will be stranded in the offset portion of the structure.

In addition to the continued problem on the left bank, now the flow over the wood crib structure has created a high velocity and turbulent condition which is naturally more attractant to fish and is highly likely encumbering fish from finding the fishway entrance. This makes it VERY unlikely fish will find the fish ladder even on the right bank. Based on our most current steelhead surveys of the mainstem bypass reach (≈ 6.2 miles), and all surveyed reaches above Electron (≈ 10 miles), only 8% of estimated adult steelhead successfully migrated upstream of the Electron Dam. During the 2021 steelhead run, an estimated 21% of adult steelhead successfully migrated upstream of the Electron Dam.
